Water Hygiene Risk Assessment in Accordance with L8

Legionella Risk Assessment

66 Boundary Road, St Albans, AL1 4DH

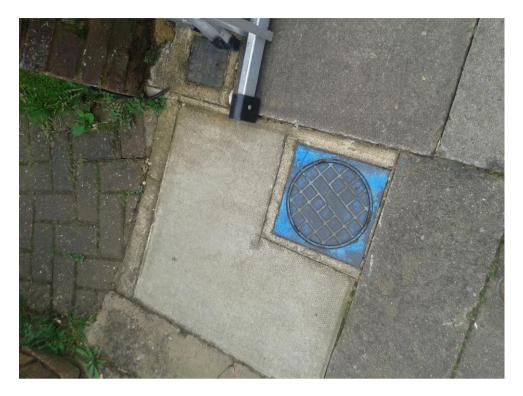
Incoming Cold Water Mains

The stop tap and water meter are located in the pathway outside the property. The mains cold water feeds the Hot Water Cylinder (HWC 1) and all of the cold water outlets on site (Bathroom, kitchen and the outside tap)

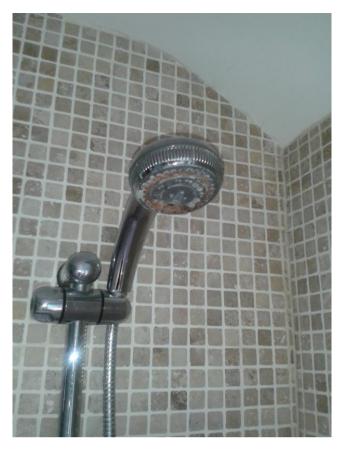
Scaled Shower Head

4@ Please ensure that all outlets are descaled, including the shower

There is a shower in the upstairs bathroom. Please ensure that this is cleaned and disinfected on a quarterly basis and that records are kept of this action.
